SUBJECT: BRAIDWOOD NUCLEAR POWER PLANT, UNITS 1 AND 2, BASELINE  
INSPECTION REPORT 05000456/2006008(DRS); 05000457/2006008(DRS);  
PRELIMINARY WHITE FINDING

Report No: 05000456/2006008; 05000457/2006008(DRS)

Facility: Braidwood Nuclear Power Station, Units 1 and 2

IR 05000456/2006008; IR 05000457/2006008(DRS); 02/13/06 - 05/25/2006; Exelon Generation Company, Braidwood Nuclear Power Station, Units 1 and 2; Event Follow-up and Public Radiation Safety.

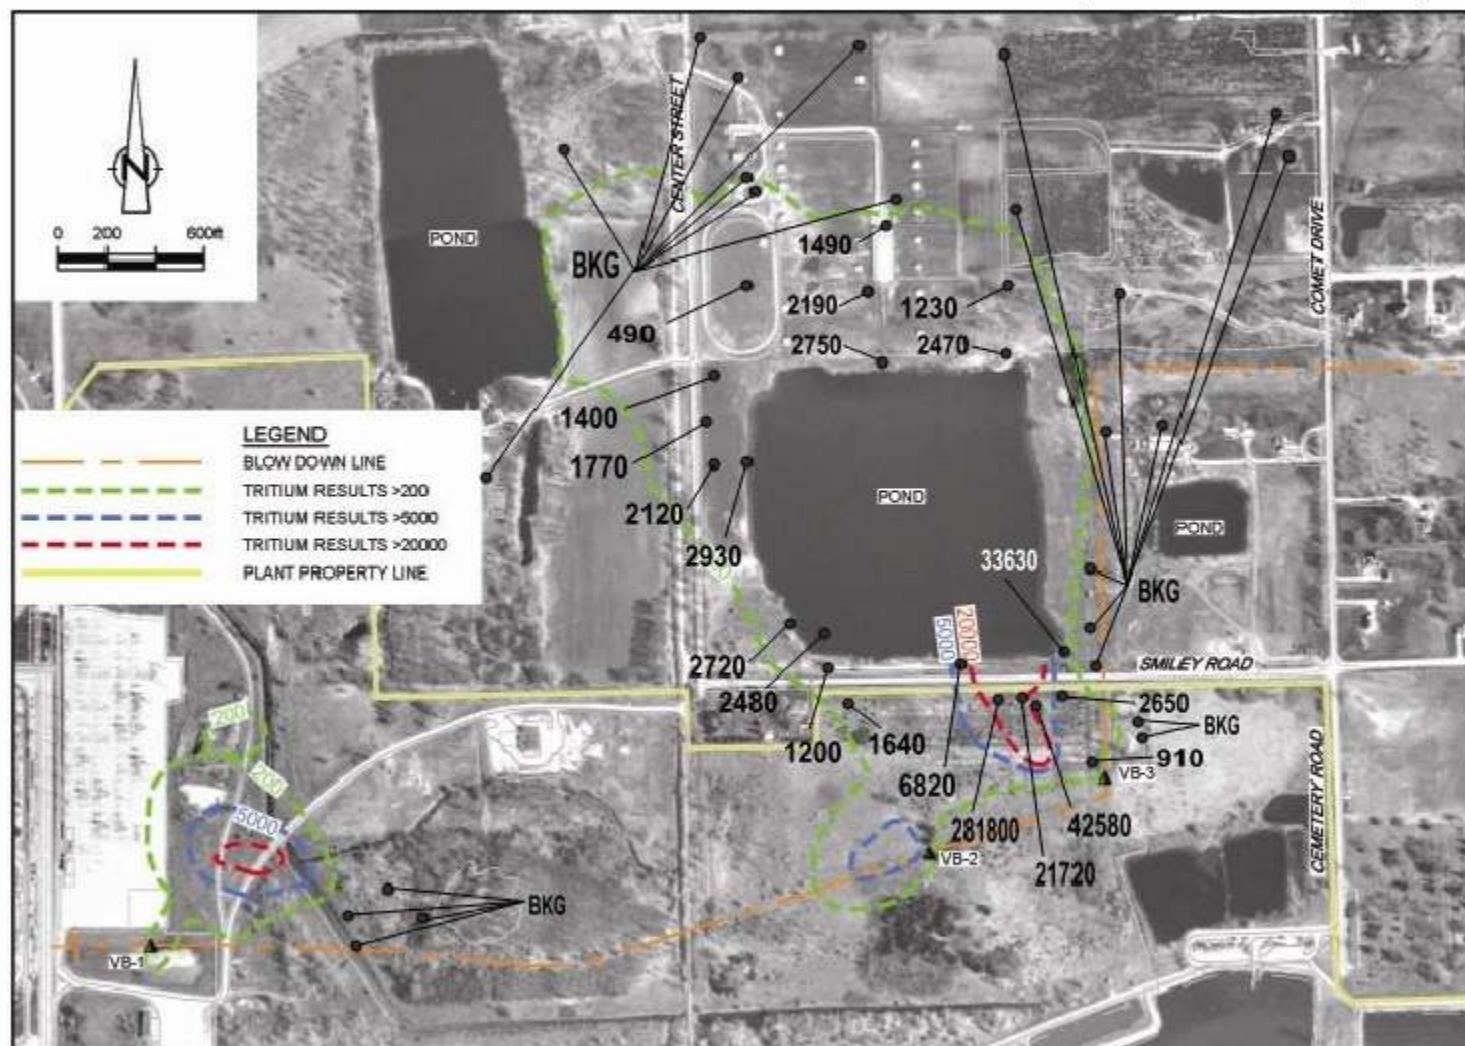
### NRC Groundwater Measurement Results

The NRC's results confirmed that tritium was present in one offsite residential well at levels of about 1300 to 1500 picocuries per liter, which is a small fraction of the EPA drinking water standard of 20,000 picocuries per liter. In all other residential wells, no measurable levels of tritium or other licensed radioactive material above normal background have been detected. In a deeper onsite groundwater well, the NRC measured tritium as high as 282,000 picocuries per liter. Measurable levels of tritium have been found offsite in shallow monitoring wells and in a pond located near plant boundary. Appendix B contains a map of the area near the plant and the corresponding tritium results from various locations. The colored dose gradients represent licensee monitoring results while the specific values annotated indicate selected NRC monitoring results

BKG = Concentrations at or below normal environmental background levels  
Numerical results in picocuries per liter
